## RECENT AND PRESENTLY ACTIVE INLETS

### Oregon Inlet

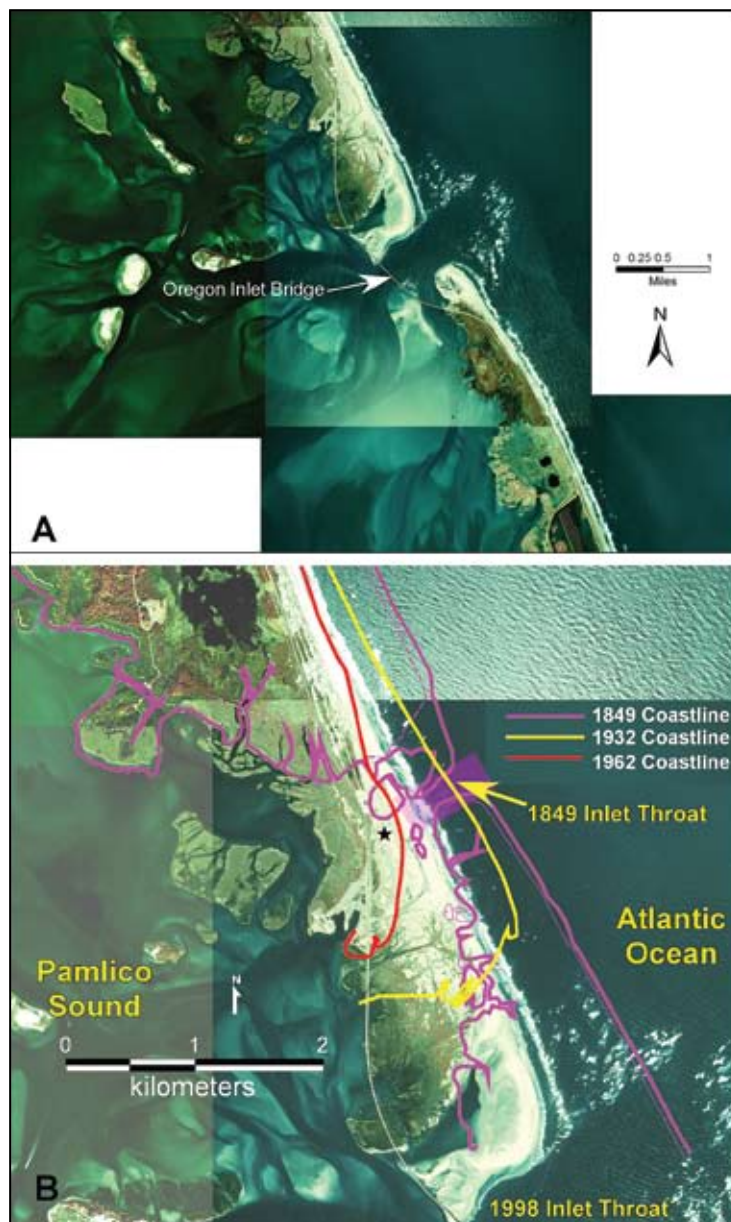
**Figure 9.** (A) Figure shows a 1998 aerial photograph of Oregon Inlet (NC State Database). (B) The 1998 aerial photograph of Oregon Inlet showing superimposed shorelines from 1849, 1932, and 1962 (following the 1962 Ash Wednesday storm), illustrating the large degree of shoreline variation and inlet migration.

Oregon Inlet (Figs. 9 and 10) opened by a hurricane in 1846 near the site of a previous inlet (Gun or Gunt Inlet) which closed in 1798. Between 1846 and 1989, the inlet migrated approximately 2 miles south of its original location (Fig. 9B). In 1962-1963 the Oregon Inlet Bridge was built (Fig. 10), but the inlet continued to migrate causing the throat channel to migrate from under the fixed navigation span and Pea Island to be almost severed from the bridge. Consequently, inlet dredging was increased to preserve the navigation channel, a rock jetty was emplaced on the south bank in 1989-1991, and a rock revetment was emplaced around the south base of the bridge to prevent further migration. However, the constrained location of the south bank, and the continued southward spit growth on the north bank caused Oregon Inlet to narrow and deepen. The narrower throat channel resulted in rapid scour beneath the central bridge pilings. As a result, rocks were emplaced beneath the free-hanging pilings.
